# Manhole Inspection Summary

Manhole # S43UU\_040MH

Insp Date: **2/12/07 12:01 PM**

**Location** Address: **1601 ABBOTSTON ST**

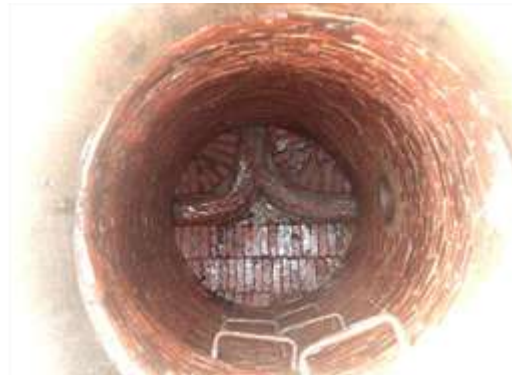
Top View

Adjustment, Corbel and Barrel infiltration.  
Corroded steps. Bench debris.

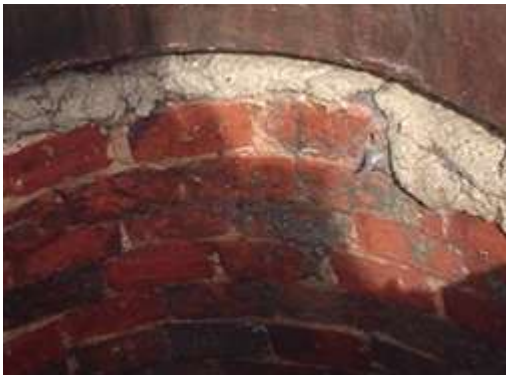
Defect

Frame leaks. Adjustment deterioration  
and infiltration.

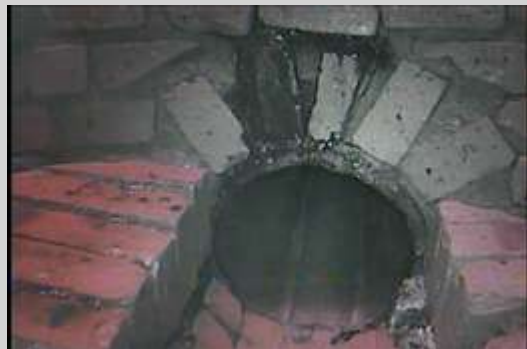
Pipe In @ 9 O'Clock

Barrel infiltration.
